**Flood Control Project Maintenance
Levee Inspections**
LMA District Cover Sheet
Spring 2017 Levee Inspection Results

Madera County FCWCA

**Flood Control Project Maintenance
Levee Inspections
Unit Cover Sheet
Spring 2017 Levee Inspection Results
Madera County FCWCA**

Waterway			Bank	Unit Miles
Unit No. 01 Ash Slough			Right	2.37
	Spring (March - May)	Summer (June - August)	(September - November) Fall	Winter (December - February)
Unit Maintenance Rating (Fall Only)				
Date of Inspection	5/4/2017 - 5/4/2017			
DWR Inspector	Herman Phillips			
Accompanied By

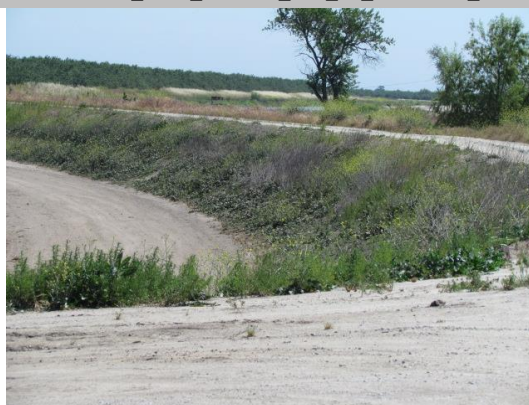
Photo 1 of 1 : SP_2017_NA0011_146_20_20170518_00024.jpg

LM Start	6.58	Rating **	U	Issue No.	20
LM End	7.04	Issue Type +	Ma	Location *	LS
Category	Earthen Levee			GPS Latitude/Longitude	
				Start	End
Item	Vegetation			36.968518 °	36.969543 °
				-120.255408 °	-120.247325 °
DWR ID	DWR_NA0011_05_s_2017_20				
Comment Code					
V2 : Remove the wild growth other than native grasses from the levee slopes.					
Inspector Comment					
Remove the wild weeds and tall grasses from the landside slope and shoulder.

Fresno River Unit 5 levee mile 6.58 looking upstream to 7.04 unsatisfactory weed growth covering levee slope.

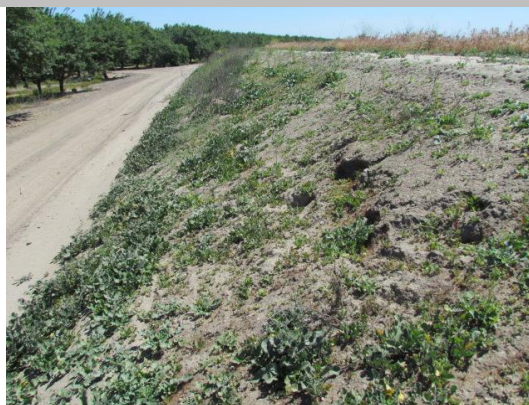
Photo 1 of 1 : SP_2017_NA0011_146_28_20170518_00026.jpg

LM Start	6.75	Rating **	U	Issue No.	28
LM End	6.95	Issue Type +	Ma	Location *	LS
Category	Earthen Levee			GPS Latitude/Longitude	
				Start	End
Item	Animal Control			36.969200 °	36.969507 °
				-120.252462 °	-120.248893 °
DWR ID	DWR_NA0011_05_f_2016_28				
Comment Code					
A1 : Exterminate rodents and backfill and compact or grout burrows.					
Inspector Comment					
Exterminate the rodents in the area listed and place bait stations along the shoulder and or slope.

Fresno River landside levee slope levee mile 6.75-6.95.

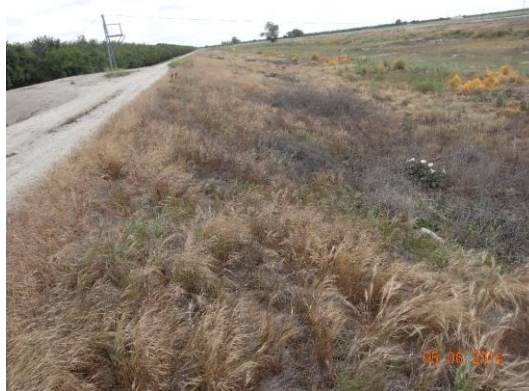
Photo 1 of 3 : UCIP_SP_2017_39006_69715.jpg

Comment Code					
Inspector Comment					
FS_ID:39006					
DS_ID:21527					
EP_NO: N/A					
Repair Type: Non-Urgent					
Crossing Status: Found					
UCIP Comments: Need to contact owner. Dense vegetation limits the inspector's visibility to identify signs of pipe failure (leaks) along the waterward slope. Recommend removing vegetation along pipe alignment to conduct proper inspection of structure and appurtenances. Slide gate buried on landward side. Recommend clearing sediment deposit on landward side.					
FIELD_STRUCT_DESC: 30-inch CM pipe through levee, 9.4 feet below the crown. Headwalls and wingwalls on both ends. Slide gate on landward end. Flap gate on waterward end.					
FS Date: 5/6/2014

View of waterward side.

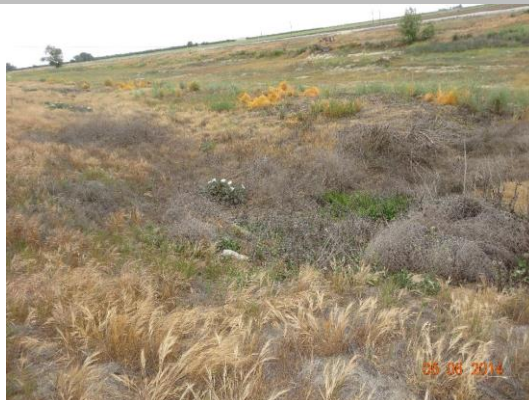
Photo 2 of 3 : UCIP_SP_2017_39006_69714.jpg

Concrete headwall covered by dense vegetation.

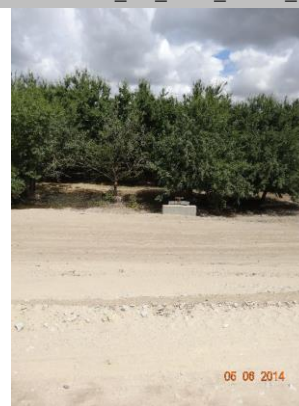
Photo 3 of 3 : UCIP_SP_2017_39006_69713.jpg

Comment Code						
Inspector Comment						
FS_ID:39006						
DS_ID:21527						
EP_NO: N/A						
Repair Type: Non-Urgent						
Crossing Status: Found						
UCIP Comments: Need to contact owner. Dense vegetation limits the inspector's visibility to identify signs of pipe failure (leaks) along the waterward slope. Recommend removing vegetation along pipe alignment to conduct proper inspection of structure and appurtenances. Slide gate buried on landward side. Recommend clearing sediment deposit on landward side.						
FIELD_STRUCT_DESC: 30-inch CM pipe through levee, 9.4 feet below the crown. Headwalls and wingwalls on both ends. Slide gate on landward end. Flap gate on waterward end.						
FS Date: 5/6/2014

View of landward side.

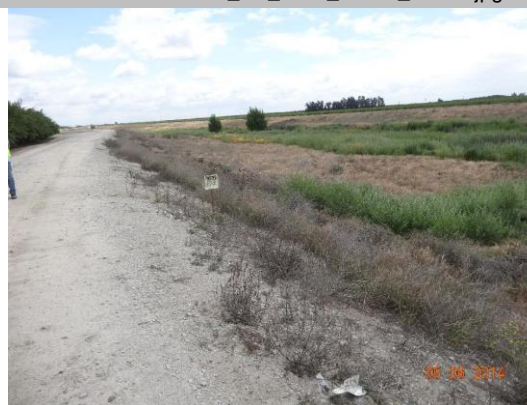
Photo 1 of 3 : UCIP_SP_2017_38235_69719.jpg

LM Start	8.09	Rating **	M	Issue No.	38
LM End	8.09	Issue Type +	En	Location *	CR
Category	Supplemental			GPS Latitude/Longitude	
				Start	End
Item	DWR UCIP Field Study			36.972415 °	36.972415 °
				-120.229285 °	-120.229285 °
DWR ID					
Comment Code					
Inspector Comment					
FS_ID:38235 DS_ID:21528 EP_NO: N/A Repair Type: Non-Urgent Crossing Status: Found UCIP Comments: Need to contact owner. Dense vegetation limits the inspector's visibility to identify signs of pipe failure (leaks) along the waterward slope. Recommend removing vegetation along pipe alignment to conduct proper inspection of structure and appurtenances. FIELD_STRUCT_DESC: 30-inch CM pipe through levee, 8.3 feet below the levee crown. Headwalls and wingwalls on both ends. Flap gate on waterward end. FS Date: 5/6/2014

View of waterward side.

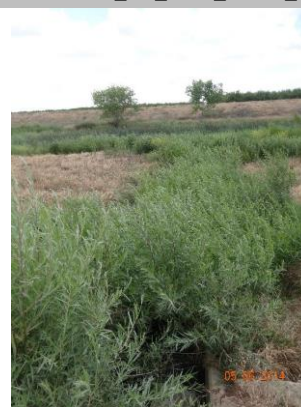
Photo 3 of 3 : UCIP_SP_2017_38235_69720.jpg

LM Start	8.09	Rating **	M	Issue No.	38 (cont)	
LM End	8.09	Issue Type +	En	Location *	CR	
Category	Supplemental			GPS Latitude/Longitude		
				Start		End
Item	DWR UCIP Field Study			36.972415 °		36.972415 °
				-120.229285 °		-120.229285 °
DWR ID						
Comment Code						
Inspector Comment						
FS_ID:38235 DS_ID:21528 EP_NO: N/A Repair Type: Non-Urgent Crossing Status: Found UCIP Comments: Need to contact owner. Dense vegetation limits the inspector's visibility to identify signs of pipe failure (leaks) along the waterward slope. Recommend removing vegetation along pipe alignment to conduct proper inspection of structure and appurtenances. FIELD_STRUCT_DESC: 30-inch CM pipe through levee, 8.3 feet below the levee crown. Headwalls and wingwalls on both ends. Flap gate on waterward end. FS Date: 5/6/2014

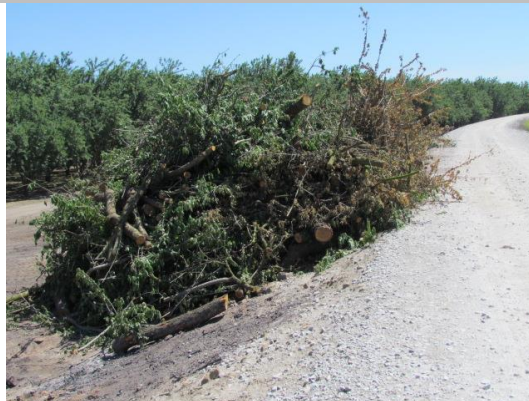
Photo 1 of 1 : SP_2017_NA0011_146_35_20170518_00025.jpg

LM Start	8.36	Rating **	U	Issue No.	35
LM End	8.41	Issue Type +	En	Location *	LS
Category	Earthen Levee			GPS Latitude/Longitude	
				Start	End
Item	Encroachments			36.972937 °	36.972947 °
				-120.224457 °	-120.223607 °
DWR ID	DWR_NA0011_05_f_2015_35				
Comment Code					
PR : Prunings					
Inspector Comment					
Burn the brush pile off the levee section, this is creating an area for rodents to bore into the levee underneath the brush pile.

Fresno River Unit 5 looking upstream from levee mile 8.36-8.41 brush pile on shoulder and slope.

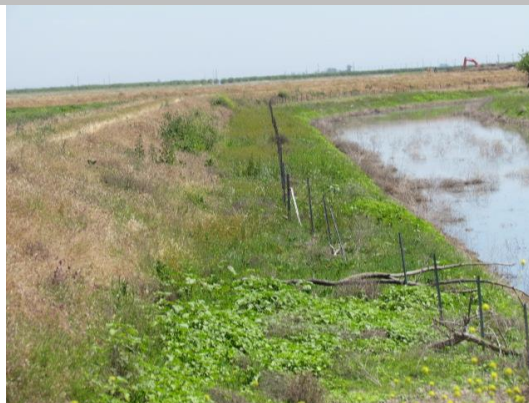
Photo 1 of 1 : SP_2017_NA0011_147_23_20170518_00033.jpg

LM Start	0.00	Rating **	U	Issue No.	23
LM End	2.48	Issue Type +	Ma	Location *	LS
Category	Earthen Levee			GPS Latitude/Longitude	
				Start	End
Item	Vegetation			36.976923 °	36.967223 °
				-120.367500 °	-120.328288 °
DWR ID	DWR_NA0011_06_f_2016_23				
Comment Code					
V1 : Control annual grass and weeds on the levee slopes and easements.					
Inspector Comment					
Remove the wild weed growth from the landward slope..

Fresno River levee mile 0.00 landside slope.

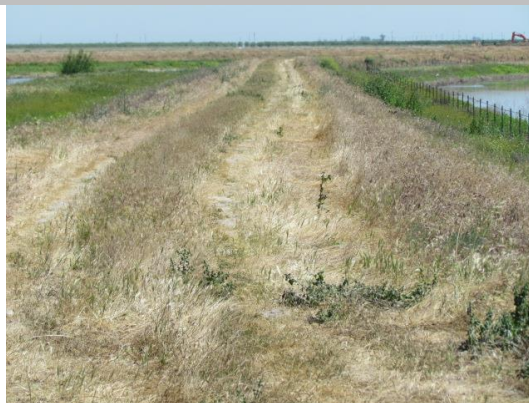
Photo 1 of 1 : SP_2017_NA0011_147_12_20170518_00035.jpg

LM Start	0.01	Rating **	U	Issue No.	12
LM End	0.95	Issue Type +	Ma	Location *	CR
Category	Earthen Levee			GPS Latitude/Longitude	
				Start	End
Item	Vegetation			36.976960 °	36.969483 °
				-120.367233 °	-120.354525 °
DWR ID	DWR_NA0011_06_s_2017_12				
Comment Code					
V9 : Keep the crown roadway free of vegetation.					
Inspector Comment					
Keep the crown roadway free of vegetation.

Fresno River looking upstream from levee mile 0.01 to 0.95.

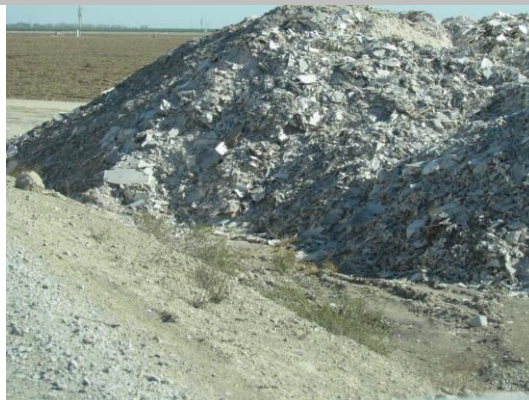
Photo 1 of 1 : SP_2017_NA0011_147_1_20170404_00001.jpg

LM Start	1.08	Rating **	U	Issue No.	1
LM End	1.13	Issue Type +	En	Location *	LS
Category	Earthen Levee			GPS Latitude/Longitude	
				Start	End
Item	Encroachments			36.967781 °	36.967407 °
				-120.353321 °	-120.352670 °
DWR ID	DWR_NA0011_06_s _ 2012_1				
Comment Code					
DE : Debris					
Inspector Comment					
Large piles of broken up recycled sheet rock placed within 10-foot of the levee easement.

Recycle sheet rock piles within the landside easement.

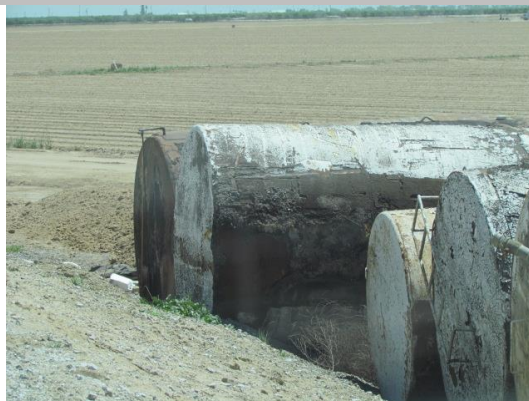
Photo 1 of 1 : SP_2017_NA0011_147_39_20170518_00037.jpg

LM Start	1.16	Rating **	U	Issue No.	39
LM End	1.16	Issue Type +	En	Location *	LS
Category	Earthen Levee			GPS Latitude/Longitude	
				Start	End
Item	Encroachments			36.967299 °	36.967299 °
				-120.352014 °	-120.352014 °
DWR ID	DWR_NA0011_06_s _ 2014_39				
Comment Code					
TA : Tank					
Inspector Comment					
Metal storage tanks are within the easement of the landward toe. Move them away from the easement.

Fresno River landside levee mile 1.16.

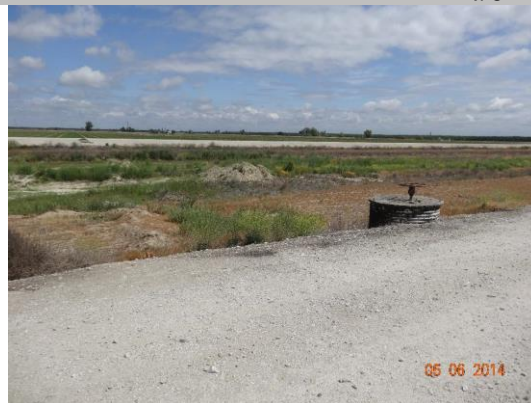
Photo 1 of 3 : UCIP_SP_2017_39008_64570.jpg

LM Start	6.17	Rating **	M	Issue No.	47
LM End	6.17	Issue Type +	En	Location *	LS
Category	Supplemental			GPS Latitude/Longitude	
				Start	End
Item	DWR UCIP Field Study			36.967568 °	36.967568 °
				-120.261594 °	-120.261594 °
DWR ID					
Comment Code					
Inspector Comment					
FS_ID:39008					
DS_ID:21531					
EP_NO: N/A					
Repair Type: Non-Urgent					
Crossing Status: Found					
UCIP Comments: Need to contact owner. Recommend removing sediment built up on landward side.					
FIELD_STRUCT_DESC: 48-inch CM pipe through levee, 11.5 feet below the crown. Slide gate on waterward shoulder. Headwalls and wingwalls on both ends. Flap gate on waterward end.					
FS Date: 5/6/2014

View of waterward side.

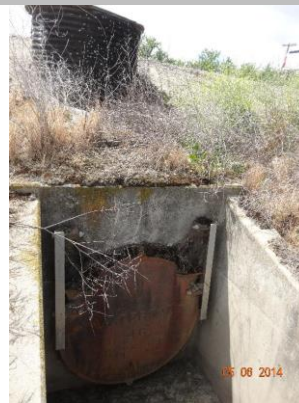
Photo 2 of 3 : UCIP_SP_2017_39008_64573.jpg

Flap gate, concrete headwall, and standpipe on waterward side.

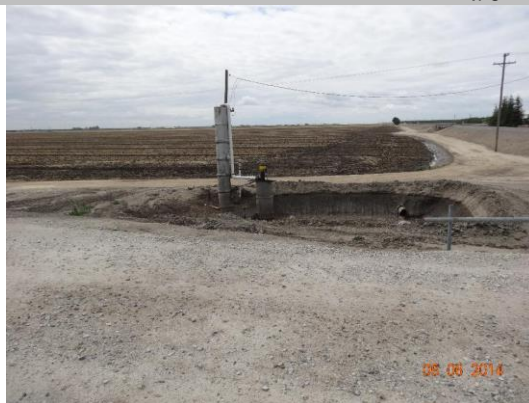
Photo 2 of 3 : UCIP_SP_2017_49980_69724.jpg

Comment Code					
Inspector Comment					
FS_ID:49980 DS_ID:21532 EP_NO: N/A Repair Type: Non-Urgent Crossing Status: Found UCIP Comments: 7/14/2016 Same as previous inspection. Need to coordinate with owner. Need permit number authorizing work. (DWR UCIP - omagana)5/06/2014 Need to contact owner. Crossing on landward side appears to be modified--no headwall found on landward end. (DWR UCIP - omagana) FIELD_STRUCT_DESC: 30-inch corrugated metal pipe through levee, 12 feet below the crown. Slide gate inside a 5-foot corrugated metal pipe riser located on the waterside (WS) shoulder. Headwalls and wingwalls are located on the WS end. Concrete headwall is located on the landside (LS) end. [Additional Reference(s): DWR Levee Log, 2005] FS Date: 7/14/2016

View of LS.

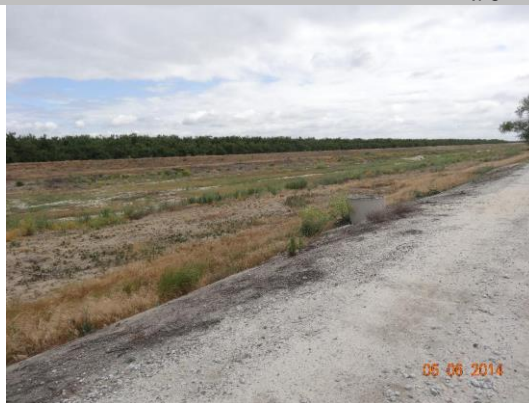
Photo 1 of 3 : UCIP_SP_2017_35804_64585.jpg

Comment Code					
Inspector Comment					
FS_ID:35804 DS_ID:21587 EP_NO: 13837 Repair Type: Non-Urgent Crossing Status: Found UCIP Comments: Need to contact owner. Dense vegetation limits the inspector's visibility to identify signs of pipe failure (leaks) along the waterward slope. Recommend removing vegetation along pipe alignment to conduct proper inspection of structure and appurtenances. FIELD_STRUCT_DESC: 12 inch diameter reinforced concrete pipe through levee at 7.5 feet below flood plane. The pipe line extends to a 27 inch concrete standpipe, located within the overflow area, through the levee section to a 30 inch diameter standpipe located on landward side. Positive closure device located on the waterward side. Walkway extends to positive closure device. (Permit No. 13837, Averill Ranch-1984) FS Date: 5/6/2014

View of waterward side.

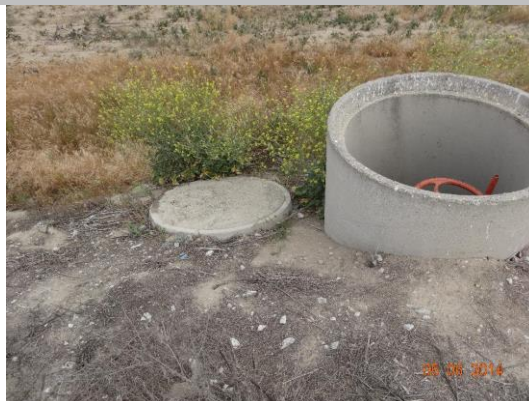
Photo 2 of 3 : UCIP_SP_2017_35804_64588.jpg

View of concrete standpipe and lid found on waterward shoulder.

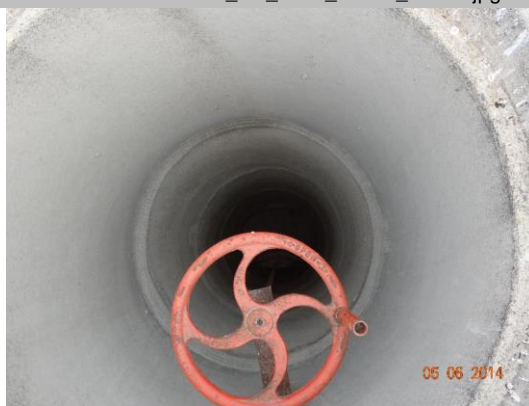
Photo 3 of 3 : UCIP_SP_2017_35804_64584.jpg

Comment Code					
Inspector Comment					
FS_ID:35804 DS_ID:21587 EP_NO: 13837 Repair Type: Non-Urgent Crossing Status: Found UCIP Comments: Need to contact owner. Dense vegetation limits the inspector's visibility to identify signs of pipe failure (leaks) along the waterward slope. Recommend removing vegetation along pipe alignment to conduct proper inspection of structure and appurtenances. FIELD_STRUCT_DESC: 12 inch diameter reinforced concrete pipe through levee at 7.5 feet below flood plane. The pipe line extends to a 27 inch concrete standpipe, located within the overflow area, through the levee section to a 30 inch diameter standpipe located on landward side. Positive closure device located on the waterward side. Walkway extends to positive closure device. (Permit No. 13837, Averill Ranch-1984) FS Date: 5/6/2014

Inside view of standpipe located on waterward side.

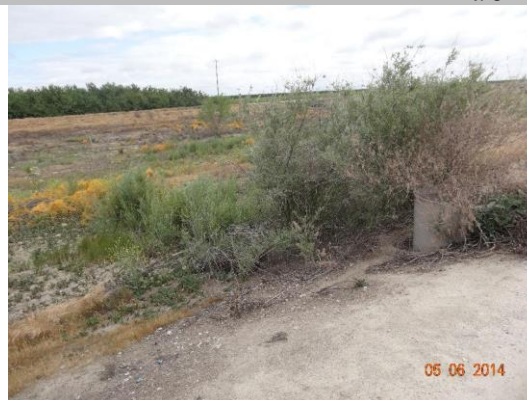
Photo 1 of 3 : UCIP_SP_2017_35805_64590.jpg

Comment Code					
Inspector Comment					
FS_ID:35805 DS_ID:21588 EP_NO: 13856 Repair Type: Non-Urgent Crossing Status: Found UCIP Comments: Need to contact owner. Dense vegetation limits the inspector's visibility to identify signs of pipe failure (leaks) along the waterward slope. Recommend removing vegetation along pipe alignment to conduct proper inspection of structure and appurtenances. FIELD_STRUCT_DESC: 12 inch diameter gravity reinforced concrete irrigation pipe through levee approximately 4 feet below crown. The pipeline extend from a 24 inch diameter standpipe, located within the overflow area, through the levee section to a 36 inch diameter standpipe located on landward side. Positive closure devise located on waterward side of the levee with an accessible walkway. (Permit No. 13856, Averill Ranch-1984) FS Date: 5/6/2014

View of waterward side.

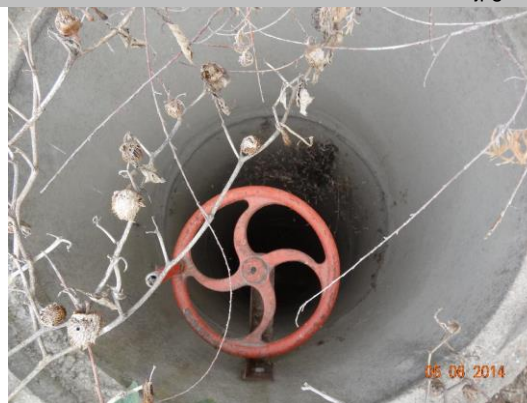
Photo 2 of 3 : UCIP_SP_2017_35805_64589.jpg

Inside view of standpipe located on waterward side.

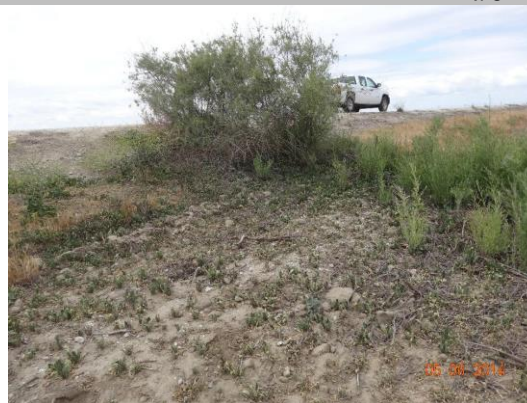
Photo 3 of 3 : UCIP_SP_2017_35805_64594.jpg

Comment Code						
Inspector Comment						
FS_ID:35805 DS_ID:21588 EP_NO: 13856 Repair Type: Non-Urgent Crossing Status: Found UCIP Comments: Need to contact owner. Dense vegetation limits the inspector's visibility to identify signs of pipe failure (leaks) along the waterward slope. Recommend removing vegetation along pipe alignment to conduct proper inspection of structure and appurtenances. FIELD_STRUCT_DESC: 12 inch diameter gravity reinforced concrete irrigation pipe through levee approximately 4 feet below crown. The pipeline extend from a 24 inch diameter standpipe, located within the overflow area, through the levee section to a 36 inch diameter standpipe located on landward side. Positive closure devise located on waterward side of the levee with an accessible walkway. (Permit No. 13856, Averill Ranch-1984) FS Date: 5/6/2014

View of waterward slope.

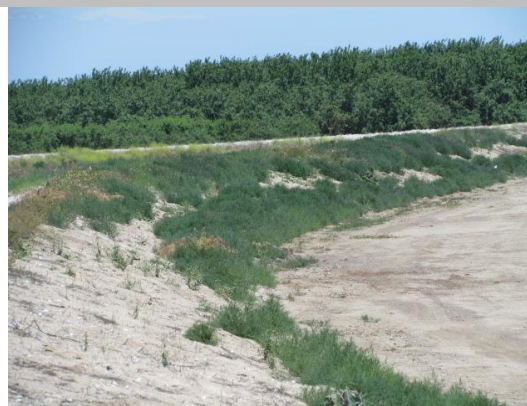
Photo 1 of 1 : SP_2017_NA0011_147_29_20170518_00038.jpg

LM Start	7.71	Rating **	U	Issue No.	29
LM End	8.59	Issue Type +	Ma	Location *	LS
Category	Earthen Levee			GPS Latitude/Longitude	
				Start	End
Item	Vegetation			36.969638 °	36.971288 °
				-120.234143 °	-120.219355 °
DWR ID	DWR_NA0011_06_s_2017_29				
Comment Code					
V2 : Remove the wild growth other than native grasses from the levee slopes.					
Inspector Comment					
Remove the wild growth from the landside slope.

Fresno River landside levee mile 7.71-8.59.

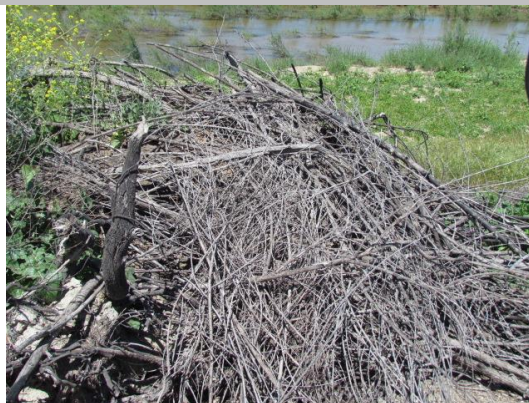
Photo 1 of 1 : SP_2017_NA0011_147_32_20170518_00039.jpg

LM Start	7.96	Rating **	M	Issue No.	32
LM End	7.96	Issue Type +	En	Location *	WS
Category	Earthen Levee			GPS Latitude/Longitude	
				Start	End
Item	Encroachments			36.971543 °	36.971543 °
				-120.230285 °	-120.230285 °
DWR ID	DWR_NA0011_06_s_2017_32				
Comment Code					
PR : Prunings					
Inspector Comment					
Remove the brush pile from the levee slope. This pile is providing habitat for rodents.

Fresno River waterside levee mile 7.96.

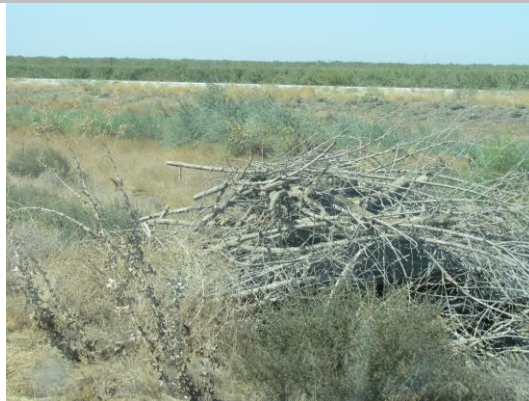
Photo 2 of 2 : SP_2017_NA0011_147_36_20170404_00011.jpg

LM Start	8.03	Rating **	U	Issue No.	36 (cont)	
LM End	8.03	Issue Type +	Ma	Location *	WS	
Category	Earthen Levee			GPS Latitude/Longitude		
				Start		End
Item	Encroachments			36.971582 °		36.971582 °
				-120.229180 °		-120.229180 °
DWR ID	DWR_NA0011_06_f_2015_36					
Comment Code						
TR : Tree or limb						
Inspector Comment						
The dead tree has been removed from blocking the roadway but still need to be removed from the levee section.

Fresno River levee mile 8.03 waterside slope and shoulder.

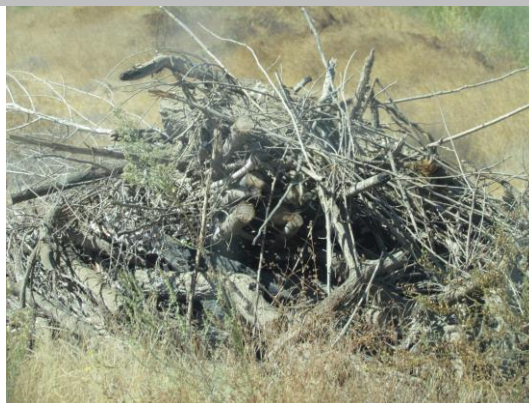
Photo 1 of 1 : SP_2017_NA0011_147_31_20170404_00009.jpg

LM Start	8.09	Rating **	U	Issue No.	31
LM End	8.09	Issue Type +	Ma	Location *	WS
Category	Earthen Levee			GPS Latitude/Longitude	
				Start	End
Item	Encroachments			36.971692 °	36.971692 °
				-120.227957 °	-120.227957 °
DWR ID	DWR_NA0011_06_f_2015_31				
Comment Code					
TR : Tree or limb					
Inspector Comment					
Remove the dead tree off the slope and shoulder, this has been reported in the last two inspections.

Fresno River levee mile 8.09.

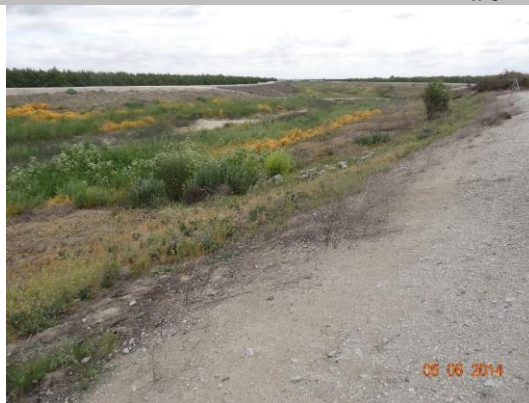
Photo 1 of 3 : UCIP_SP_2017_35806_64596.jpg

LM Start	8.53	Rating **	M	Issue No.	51
LM End	8.53	Issue Type +	En	Location *	WS
Category	Supplemental			GPS Latitude/Longitude	
				Start	End
Item	DWR UCIP Field Study			36.971462 °	36.971462 °
				-120.220276 °	-120.220276 °
DWR ID					
Comment Code					
Inspector Comment					
FS_ID:35806 DS_ID:21534 EP_NO: N/A Repair Type: Non-Urgent Crossing Status: Found UCIP Comments: Need to contact owner. Rip rap has been added around concrete headwall on waterward side--need to determine details for rip rap around structure. FIELD_STRUCT_DESC: 30-inch CM pipe through levee, 11.0 feet below crown. Headwalls and wingwalls on both ends. Flap gate on waterward end. FS Date: 5/6/2014

View of waterward side.

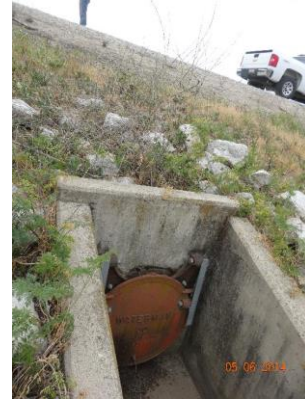
Photo 3 of 3 : UCIP_SP_2017_35806_64598.jpg

LM Start	8.53	Rating **	M	Issue No.	51 (cont)	
LM End	8.53	Issue Type +	En	Location *	WS	
Category	Supplemental			GPS Latitude/Longitude		
				Start		End
Item	DWR UCIP Field Study			36.971462 °		36.971462 °
				-120.220276 °		-120.220276 °
DWR ID						
Comment Code						
Inspector Comment						
FS_ID:35806 DS_ID:21534 EP_NO: N/A Repair Type: Non-Urgent Crossing Status: Found UCIP Comments: Need to contact owner. Rip rap has been added around concrete headwall on waterward side--need to determine details for rip rap around structure. FIELD_STRUCT_DESC: 30-inch CM pipe through levee, 11.0 feet below crown. Headwalls and wingwalls on both ends. Flap gate on waterward end. FS Date: 5/6/2014

Flap gate visible on waterward side.

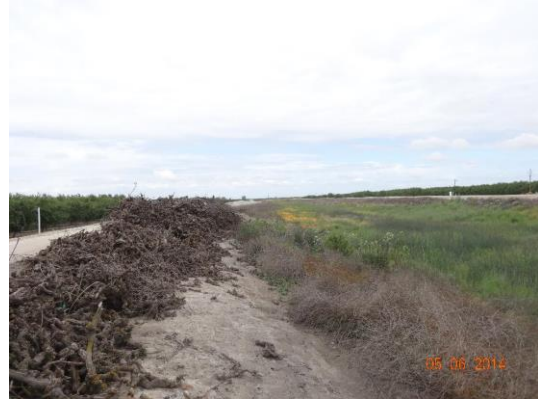
Photo 1 of 3 : UCIP_SP_2017_49981_64605.jpg

Comment Code					
Inspector Comment					
FS_ID:49981 DS_ID:21530 EP_NO: N/A Repair Type: Urgent Crossing Status: Found UCIP Comments: 7/14/2016 Surface erosion still present on LS shoulder. Unable to determine if surface erosion is due to internal pipe failure. Unable to locate concrete headwall on WS toe. Need to coordinate with owner to address erosion or potential pipe failure. Also recommend removing dense vegetation on WS. (DWR UCIP - omagana)5/06/2014 Need to contact owner. Surface erosion on landward slope unable to determine if pipe failed or if rodent activity burrow hole has caused collapse on slope. Need to determine cause for erosion. (DWR UCIP - omagana) FIELD_STRUCT_DESC: 30-inch corrugated metal drainage pipe through levee, 10.2 feet below crown. Headwalls and wingwalls are located on both waterside (WS) and landside (LS) ends. Flap gate is located on the WS end. FS Date: 7/14/2016

View of WS.

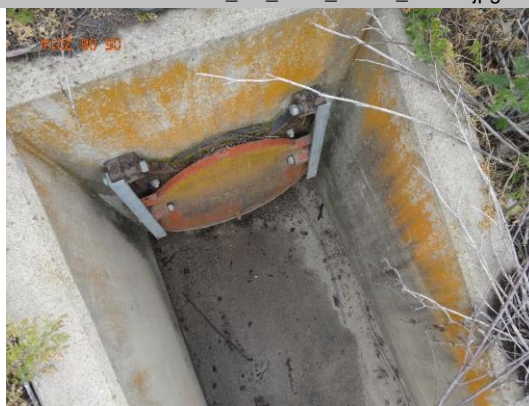
Photo 2 of 3 : UCIP_SP_2017_49981_64604.jpg

FS_ID:49981
DS_ID:21530
EP_NO: N/A
Repair Type: Urgent
Crossing Status: Found
UCIP Comments: 7/14/2016 Surface erosion still present on LS shoulder. Unable to determine if surface erosion is due to internal pipe failure. Unable to locate concrete headwall on WS toe. Need to coordinate with owner to address erosion or potential pipe failure. Also recommend removing dense vegetation on WS. (DWR UCIP - omagana)5/06/2014 Need to contact owner. Surface erosion on landward slope unable to determine if pipe failed or if rodent activity burrow hole has caused collapse on slope. Need to determine cause for erosion. (DWR UCIP - omagana)
FIELD_STRUCT_DESC: 30-inch corrugated metal drainage pipe through levee, 10.2 feet below crown. Headwalls and wingwalls are located on both waterside (WS) and landside (LS) ends. Flap gate is located on the WS end.
FS Date: 7/14/2016

LM Start	8.94	Rating **	U	Issue No.	52 (cont)
LM End	8.94	Issue Type +	En	Location *	WS

Flap gate visible on WS.

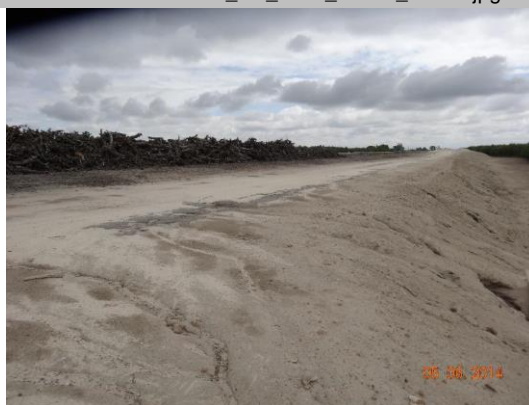
Photo 3 of 3 : UCIP_SP_2017_49981_64603.jpg

View of LS.
